Procedia Engineering 10 (2011) 346–349

## Collapse of a coal loadout structure from fatigue caused by wind-induced vibration

Iain Le May\*

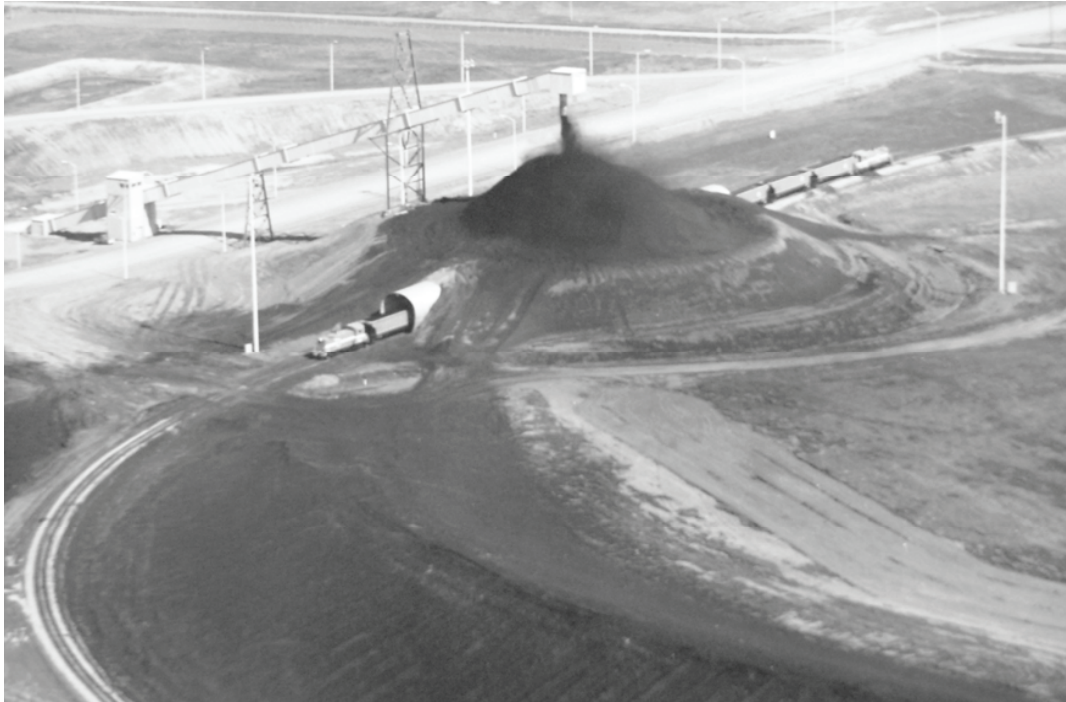
Fig. 1. Coal loadout stage in operation, transferring coal to hopper cars.

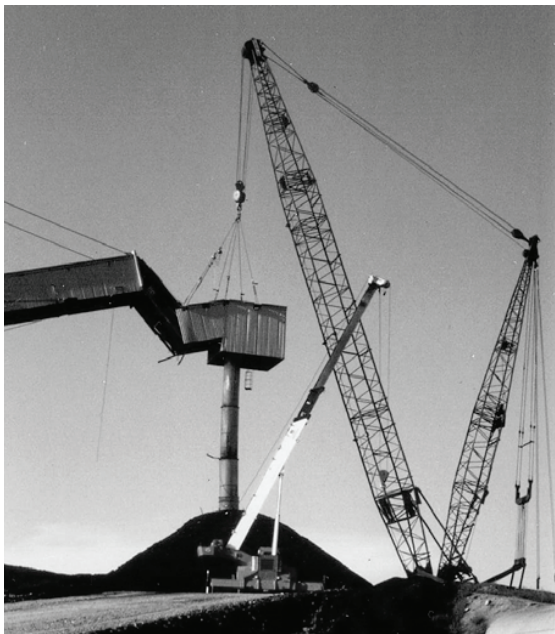
Fig. 1 shows the coal loadout stage prior to the failure and Fig. 2 shows the failure of the cantilevered end section after the failure event. Fig. 3 illustrates the structure of the stage in greater detail.

Fig. 2. Head chute embedded in coal heap after failure of the structural members at the start of the cantilevered section of the loadout stage.

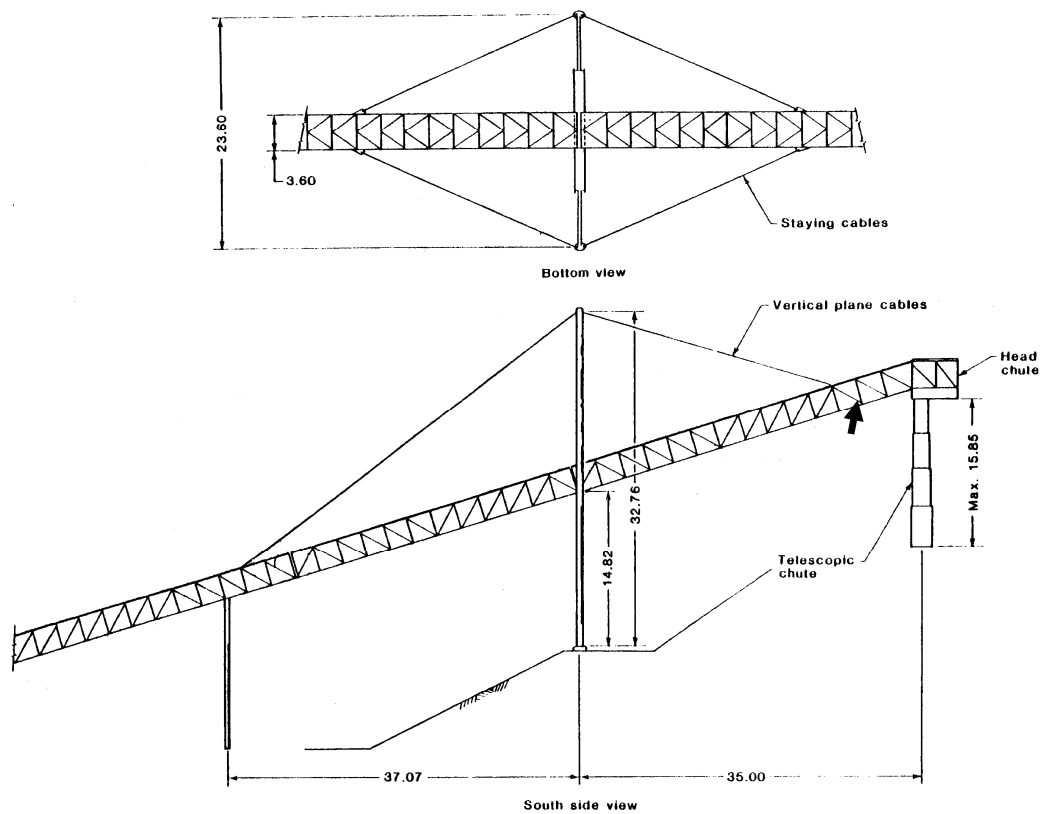
The initial failure occurred at the welded connections between the diagonal members indicated in Fig. 3 and shown more clearly in Fig. 4.

Fig 3. Schematic diagram of the structure of the loadout stage. The arrow indicates the joints where collapse started. The dimensions are shown in metres.

It may be noted that the weld sizes were small (Fig. 3) and that joints were of the partial penetration type, not construction details that are appropriate for conditions in which high resistance to fatigue would be required.

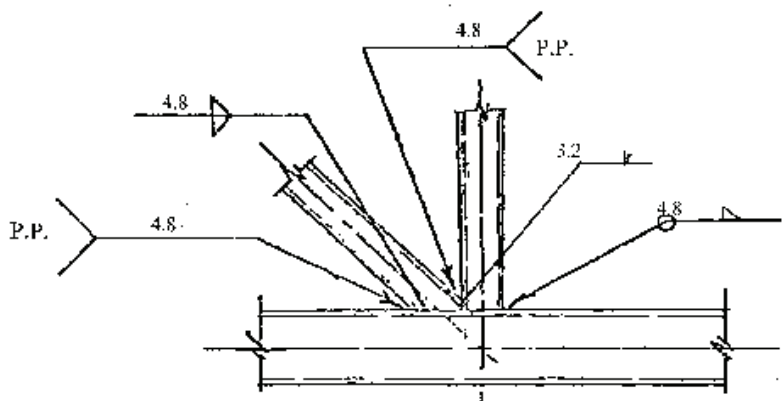
Fig. 4. Detail of the failed joint. Weld sizes are in mm.

The one matter in which doubt over fatigue as the cause of failure was still being expressed, namely the absence of clear fatigue striations, could now be cleared up. The fracture surfaces corresponding to the joints at which the initial failures had occurred had a morphology of ductile dimples that were essentially aligned. As the mean stress in these regions was very high, a mechanism of fatigue by progressive incremental tensile tearing with each stress cycle was concluded to have occurred.

The structure was rebuilt with more substantial connections and welds, together with precautions to prevent possible build-up of excess coal that could produce an overload condition.

Subsequently the structure was modified further to eliminate the presence of the cantilevered section by provision of an A-frame straddling the head chute and coal heap, and supporting the head frame directly. As the structure was later scrapped, together with the distribution system involving the rail link, for economic reasons, the writer has been unable to provide a photograph of the modifications made for the final limited time of operation.
